A COMPENDIUM OF
BETTER RENOVATIONS & RETROFITS
IN THE NORTHEAST

*A proposed initiative of the Northeast Sustainable Energy Association's **BuildingEnergy Online Program***

A COMPENDIUM OF BETTER RENOVATIONS & RETROFITS 2026 COHORT of CONTRIBUTORS

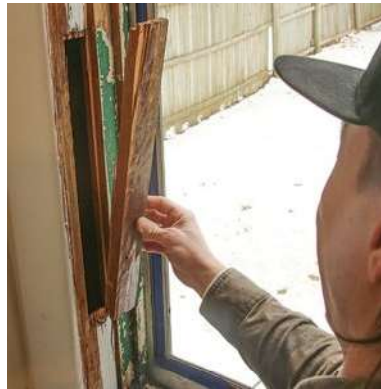
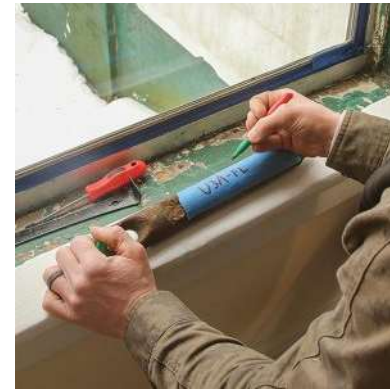
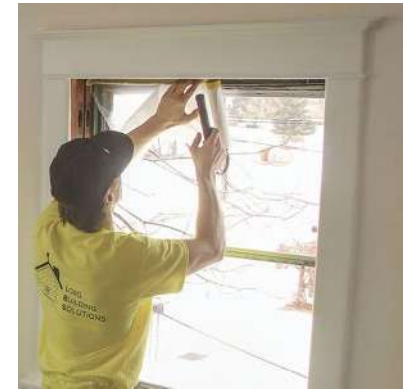
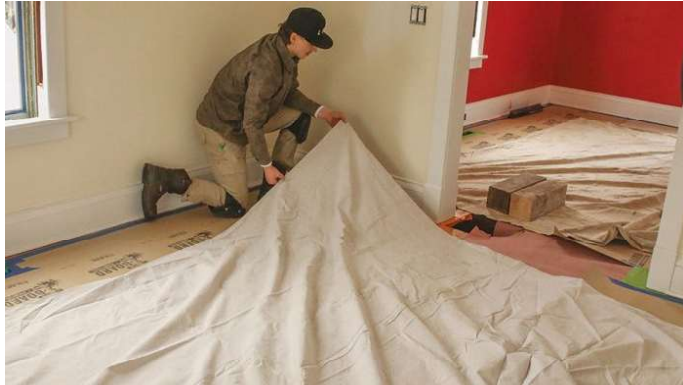
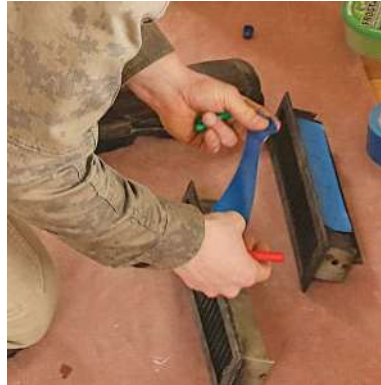
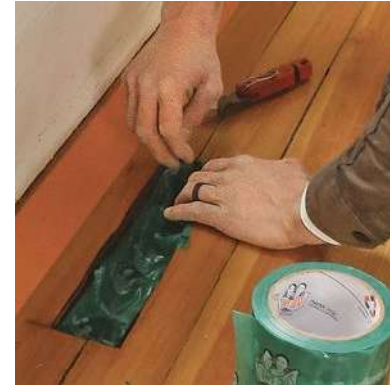
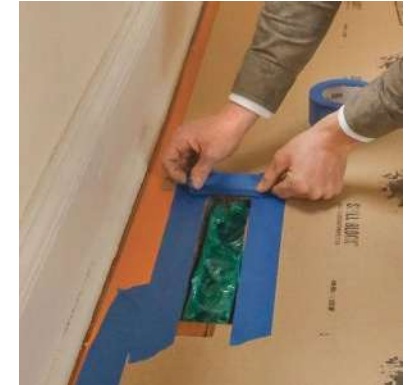
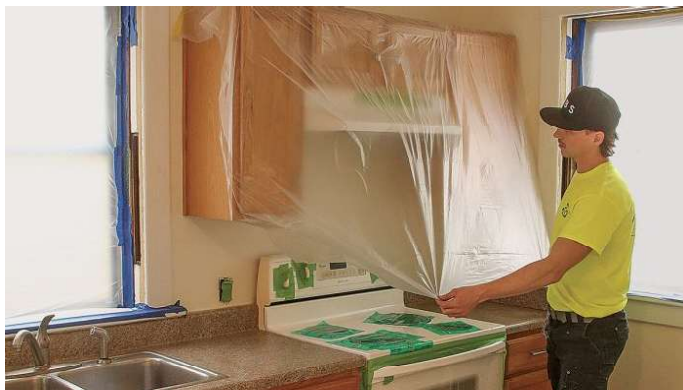
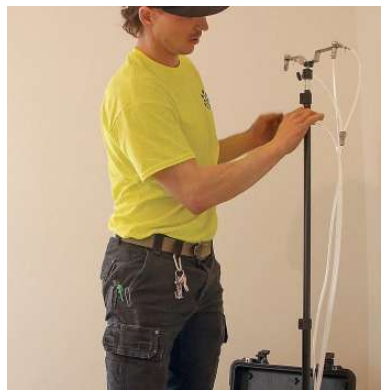
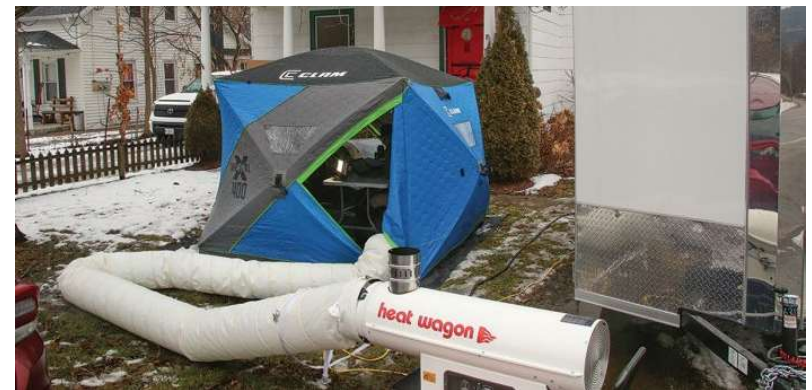
AEROBARRIER PROCESS

- Protect Surfaces
- Close Off Mechanical Systems
- Protect Fixtures
- Prep Windows
- Place Spray Heads
- Connect Air Supply
- Turn Up The Heat
- Seal & Monitor

To address what couldn't be accessed without demolition, the team brought in AeroBarrier, a spray-applied sealant that pressurizes the house to force sealant into micro-gaps. Because the building was unoccupied, masking, protection, and equipment staging were manageable, allowing sealing of board-sheathing gaps, sash pockets, register perimeters, duct boots, and other hard-to-reach areas.

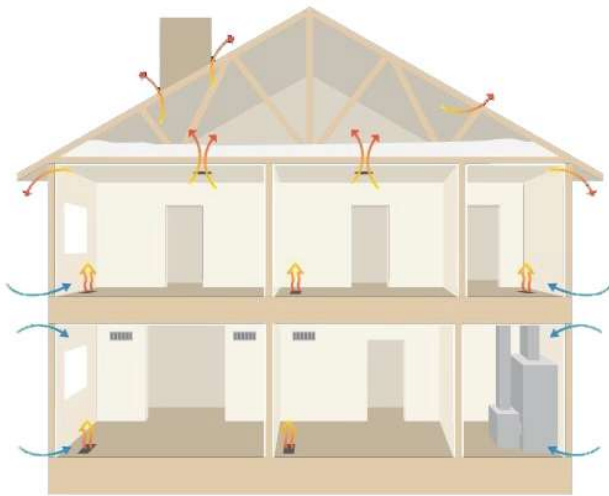
BEFORE | AEROSEAL

TYPICAL AEROSEAL DIAGRAMS

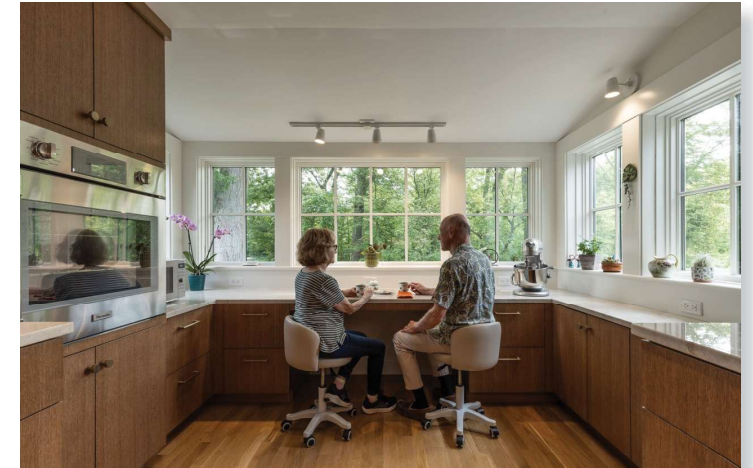
BEFORE | AIR & INSULATION

AFTER | AIR & INSULATION

Performance upgrades were equally important: the roofline was fully insulated; a ducted heat pump and ERV with MERV 13 filtration were added; combustion appliances were eliminated; and both kitchen ventilation and radon mitigation were addressed. Because this was a partial renovation, many air leaks were originally hidden within the existing envelope. The homeowners committed fully and temporarily cleared their home to allow for a whole-house Aerobarrier application. The result: nearly a 90% reduction in air leakage, surpassing today's new construction requirements.

Whole-house air sealing using Aerobarrier can be transformative in partial renovations, especially when hidden leakage pathways can't be accessed.

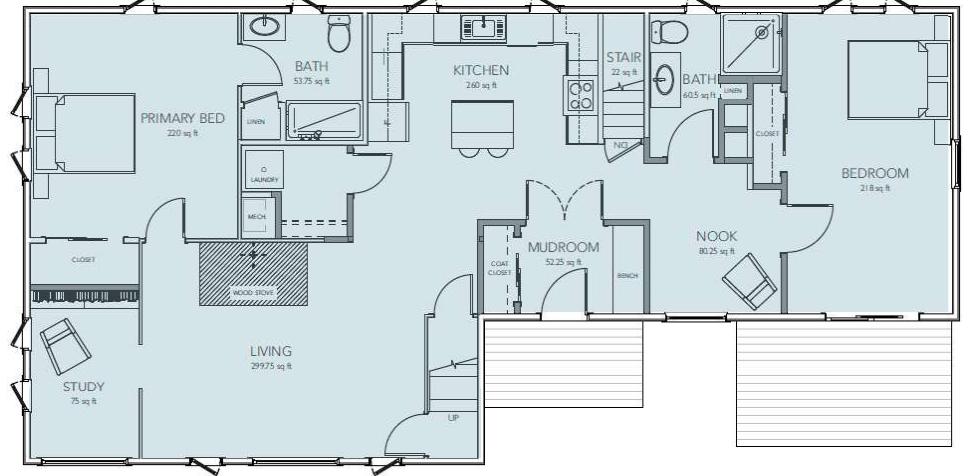
1 PROPOSED FIRST FLOOR PLAN
SCALE: 1/8" = 1'-0"

- EXISTING
- RENOVATION
- NEW CONSTRUCTION

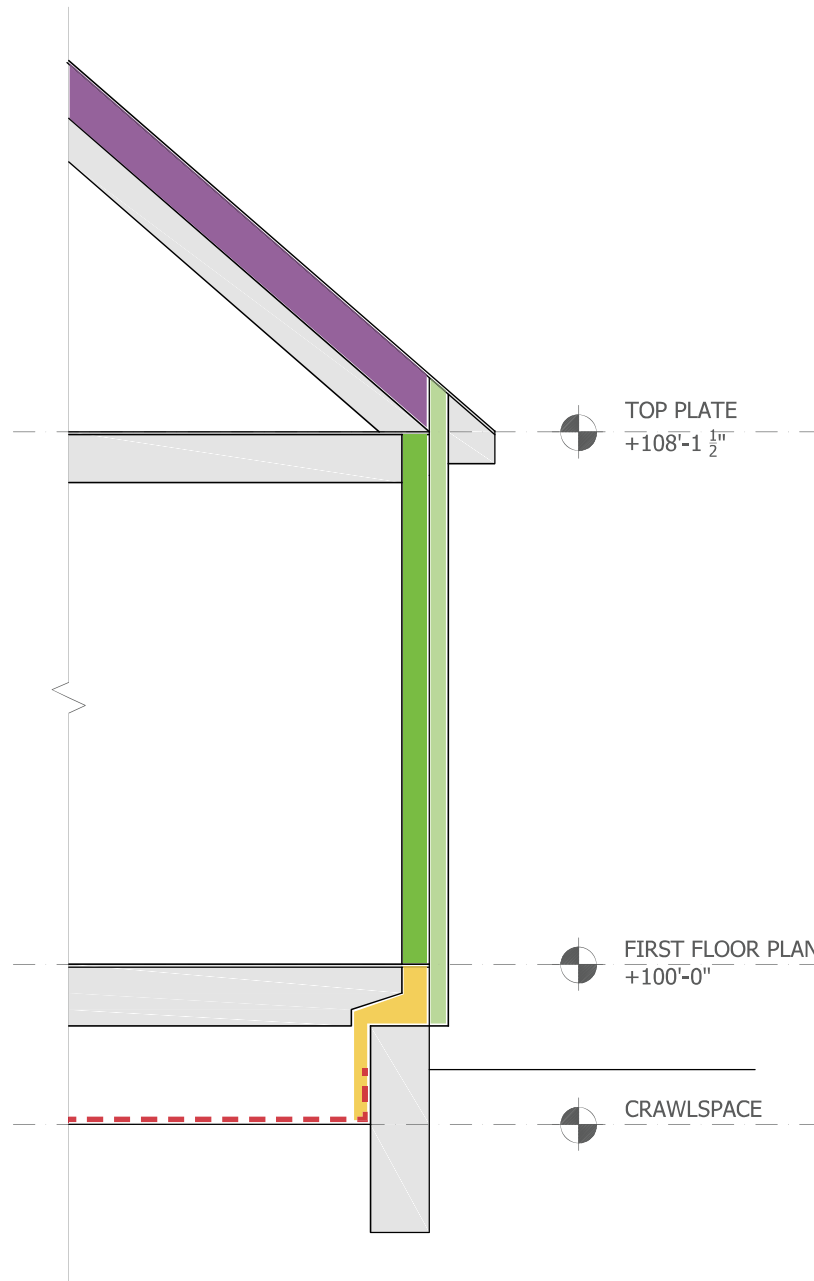
TYPICAL WALL SECTION

-   **ROOF OR CEILING:**
 - CONTINUOUS R-49 POLYISO RIGID FOAM

**FOUNDATION:**
 - CLOSED-CELL SPRAY FOAM: R-20

**EXISTING STRUCTURE**

- ROOF:** Wood; Variable size rafters
- 8 **INSULATION**
 - SUBSLAB:** None; Added poly vapor barrier
 - FOUNDATION:** R-20 Closed-cell spray foam
 - ABOVE-GRADE WALL:** R-14 Cellulose
R-12 Cont. ext. EPS foam

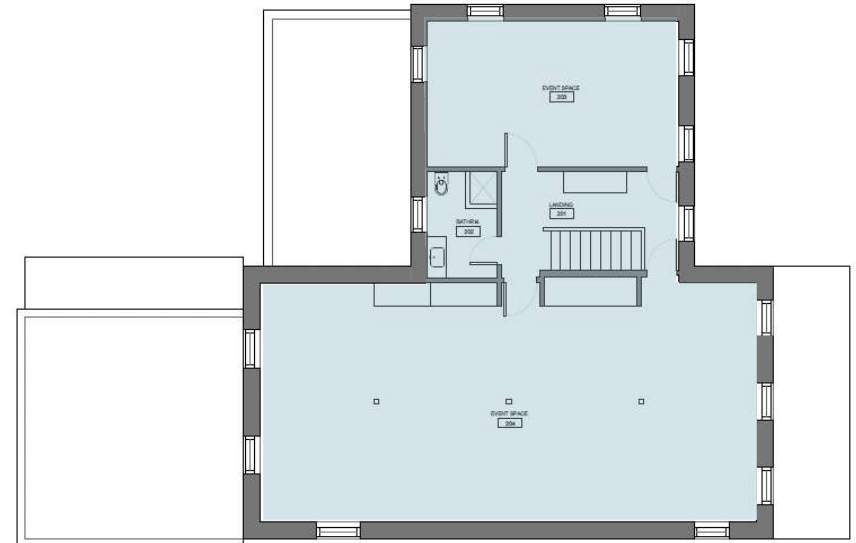
AFTER | SECOND FLOOR PLAN

- EXISTING
- RENOVATION
- NEW CONSTRUCTION

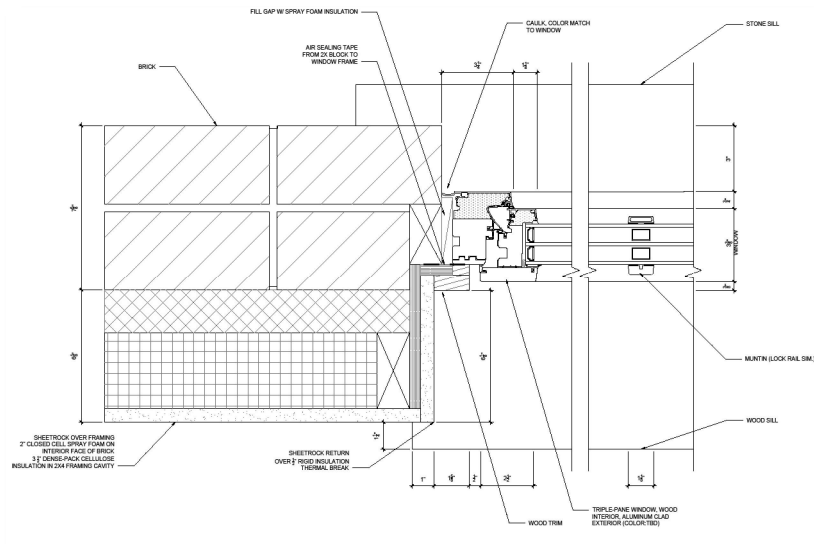
JAMB DETAIL | WOOD/CLAD WINDOW

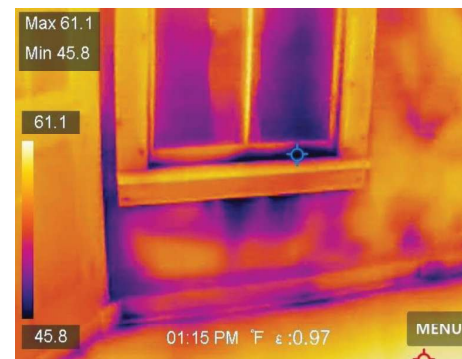
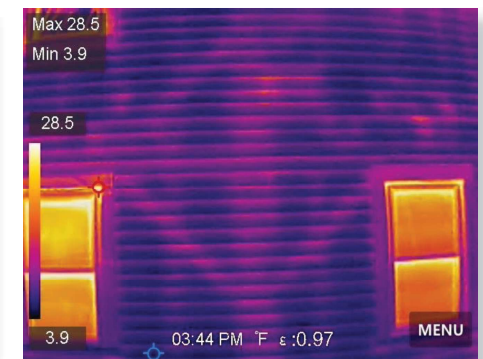
USED AN INFRARED CAMERA FOR INSULATION DIAGNOSTICS

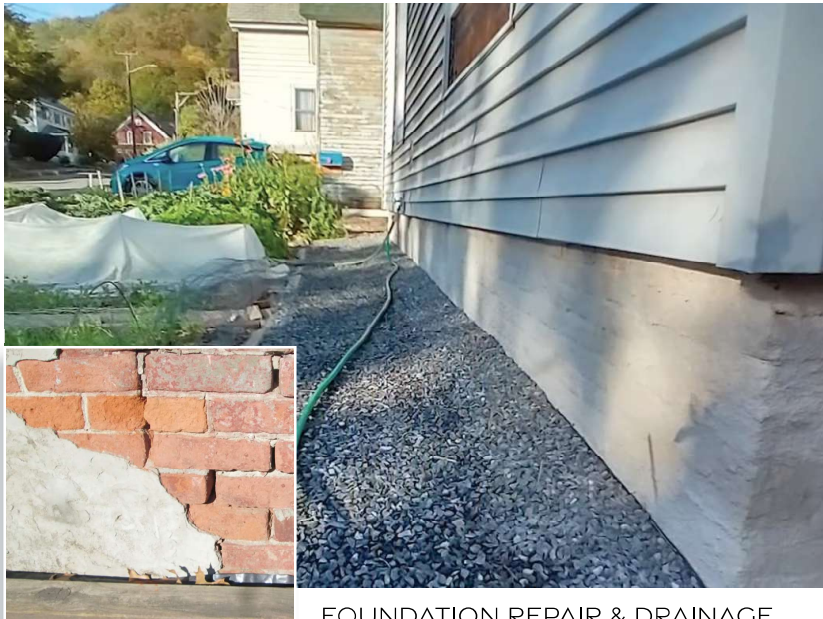
FOUNDATION REPAIR & DRAINAGE

- PERIMETER DRAIN --> SUMP
- WATER-RESISTANT BARRIER (CRAWL/ BASEMENT FLOOR)
- MOISTURE + AIR CONTROL FOUNDATIONAL WORK

- REPAIRED BRICK FOUNDATION & APPLIED PARGE COAT
- BELOW GRADE HORIZONTAL RUBBER MEMBRANE PITCHED 1"/FT
- GRAVEL TOP LAYER

WATER WINS FIRST: Drainage improvements, foundation repair, and moisture control must precede all envelope upgrades.

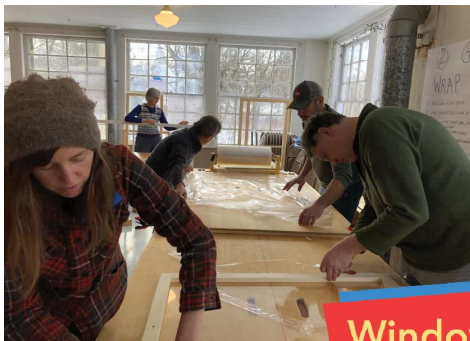
COMMUNITY MEMBERS BUILD AFFORDABLE, INSULATING WINDOW INSERTS

INSULATING WINDOW INSERTS
windowdressers.org

- Remove the pulleys & sash weights. Fill sash weight pockets with insulation & install spring replacement balances.
- Install spring bronze weatherstripping & good quality triple track aluminum storm windows.
- Window Dressers from Maine does “community-build” insulating window insert projects.

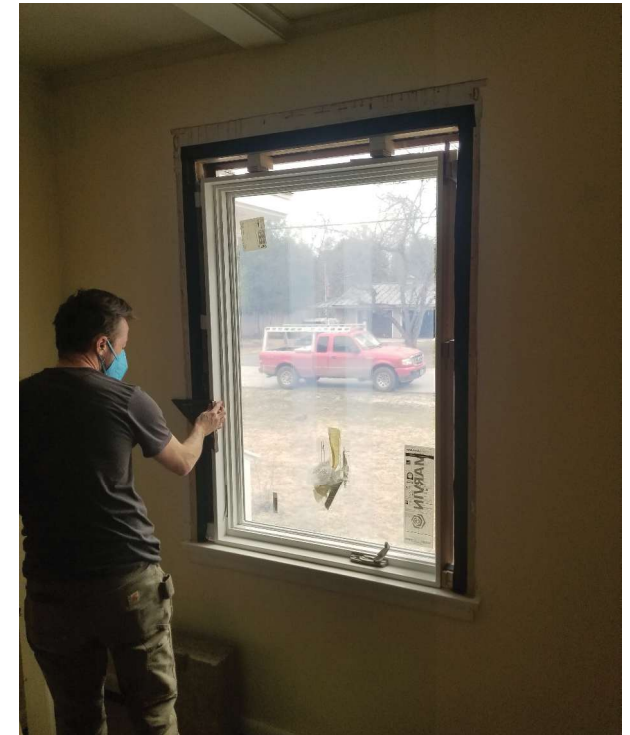
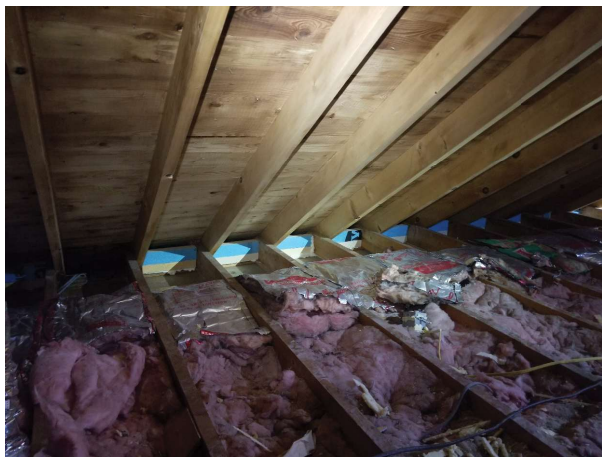
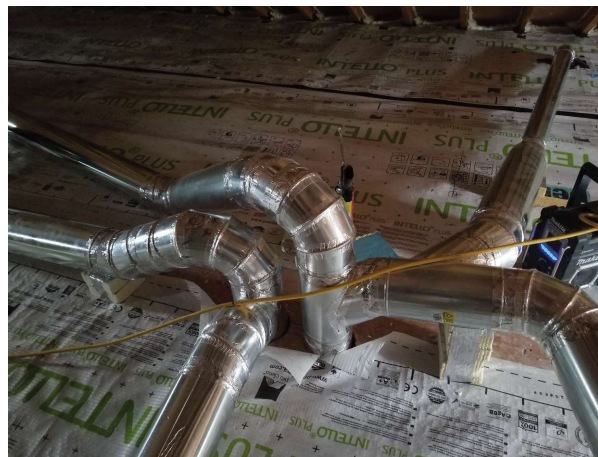
TYPICAL WALL SECTION

- ROOF OR CEILING:**
- CORBELLED PIECES OF 2" SCRAP FOAM
 - 22" LOOSE-FILL CELLULOSE
 - INSULATION BAFFLE

- FOUNDATION:**
- 4" FOIL-FACED POLYISO FOAM BOARD

- FLOOR - BELOW GRADE**
- NO TREATMENT

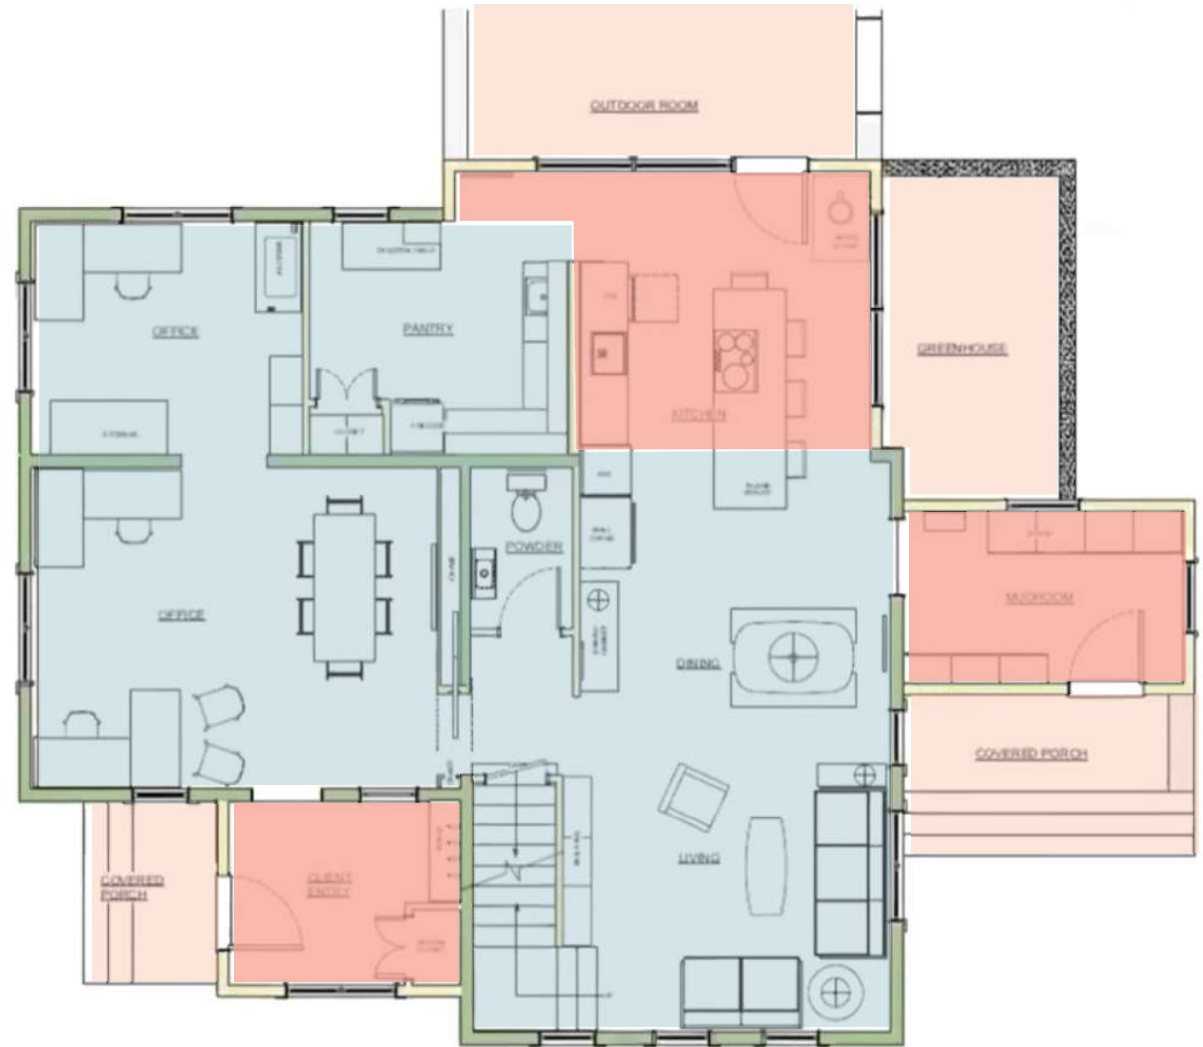
- EXISTING
- RENOVATION
- NEW CONSTRUCTION

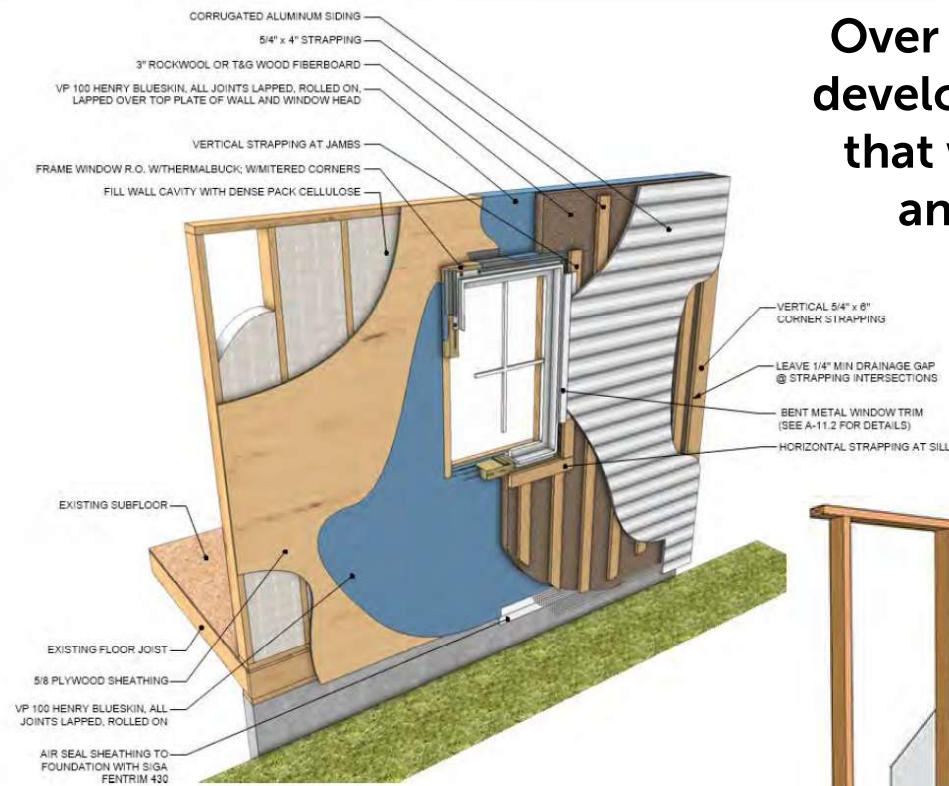
SUSTAINABLE DESIGN'S WALL ASSEMBLY

"At first, we had to convince builders and clients of its durability. Shortly afterward, Joe Lstiburek published a paper describing the same assembly, which validated our approach. Since then, new products have made this wall system even easier: Henry VP100 Blueskin self-adhered membrane, ThermalBuck for rough openings, and acrylic tapes for flashing."

Over ten years ago, we developed a wall system that was both airtight and vapor-open.

- Airtight and vapor-open wall assembly (validated by building science research).
- Strapping creates a drainage plane behind the siding.
- Continuous exterior insulation reduces condensation risk.
- Waterproofed foundation walls + Gravel under slab for drainage and insulation.
- Landscape swales were created to direct stormwater to rain gardens.

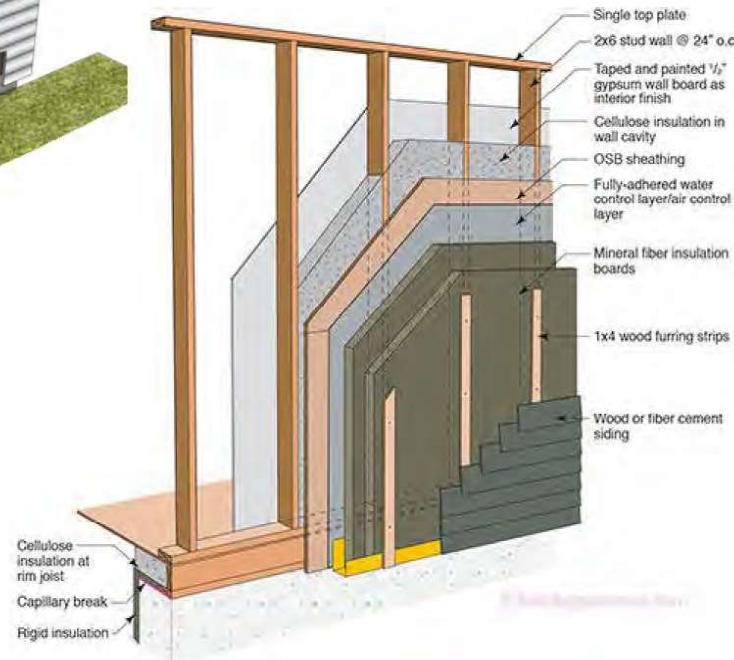
BUILDING SCIENCE'S WALL ASSEMBLY

Source: buildingscience.com, BSI-091 Flow-Through Assemblies, Figure 5; Used with permission.
