CERTIFIED LEAKAGE REPORT

Avesta Housing - Meadowview II
16 Hancock St
04039, ME 04039
Phone:
Square Footage: 9765

System Description:Ventilation System - ERV

Seal Description:First Floor

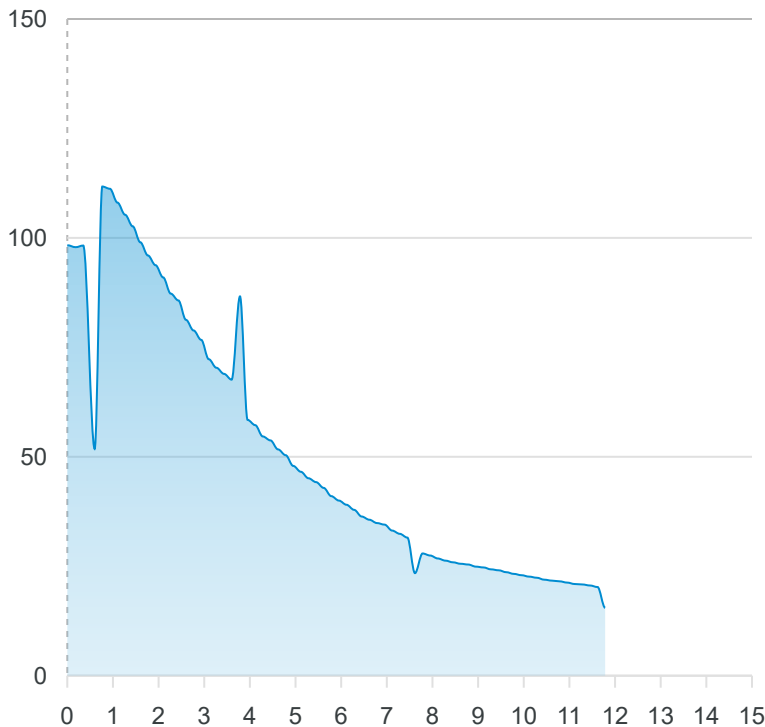
Leakage (CFM₂₅)

Duct leakage results are calculated in Cubic Feet per Minute (CFM) calculated at a STANDARD OPERATING PRESSURE of 25 Pa.

Initial	Final
CFM ₂₅	98	16
CFM ₂₅ /100 ft ²	1.0	.2
Equivalent Hole Size	18.6 in ²	2.9 in ²
% System Capacity	7.0%	1.1%
